MERRIMACK VILLAGE DISTRICT ASSET MANAGEMENT PLAN

November 2014

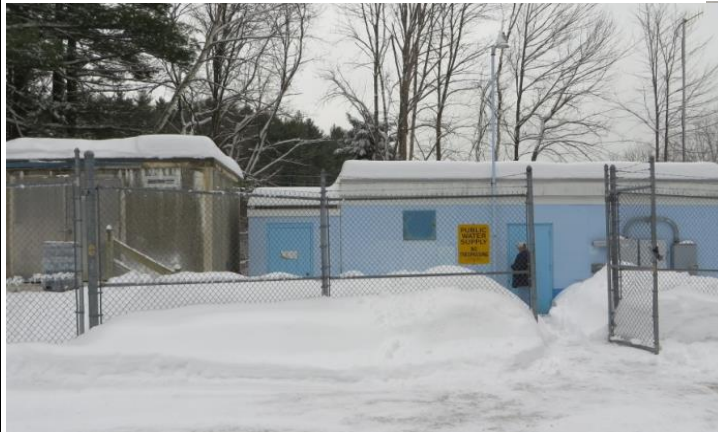
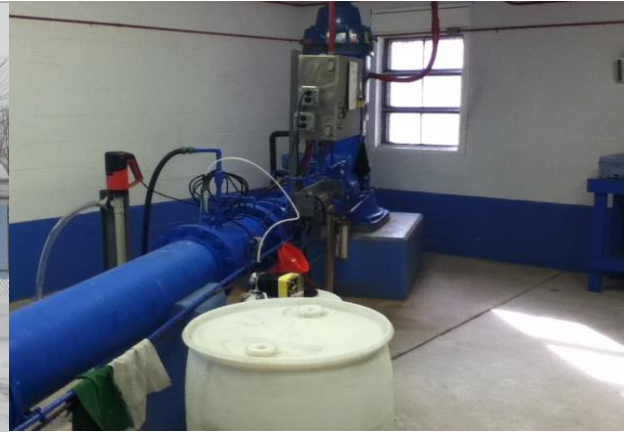
ASSET INVENTORY	
MERRIMACK VILLAGE DISTRICT TOWN OF MERRIMACK, NH	
Name: Well #2	
Updated: February 2014	
Improvements Needed	
	New lime station
	Well level monitoring, SCADA RTU upgrade
	Increase pump capacity to 1500 GPM (new pump, VFD, etc.)
	Provide ramp down (with new VFD)

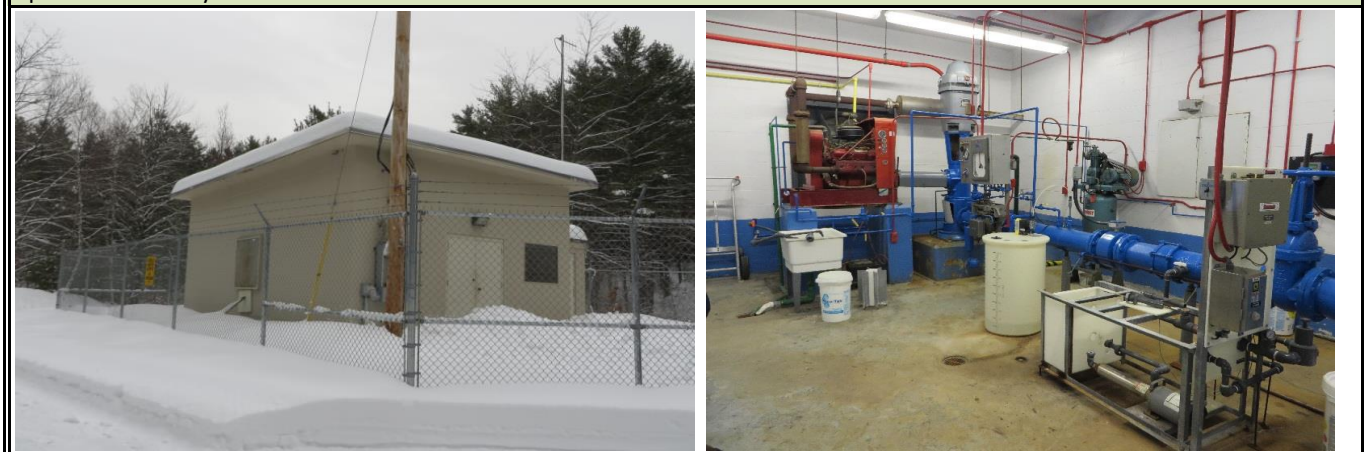
ASSET INVENTORY	
MERRIMACK VILLAGE DISTRICT TOWN OF MERRIMACK, NH	
Name: Well #3	
Updated: February 2014	
Well Information	
Well type	gravel pack
Casing size, in	
Grade elevation, ft MSL	205 per water model
Suction depth, ft	45
Well depth, ft	69.65
Approved yield, gpm	800
Last cleaning date	2,008
Water quality	Fe/Mn rise with use
Notes	
Instrumentation	
Flowmeter	8" magmeter
Level monitoring	none
Chorine monitor	Hach CL17
pH monitor	Foxboro T222 in lime station
Pressure sensor	none
Telemetry	SCADA RTU, radio telemetry
Structural/Architectural	
Size	540 SF
Building walls	CMU block
Roof	
Doors	Steel
Lime Building	Precast Concrete, 225 SF
Electrical	
Primary Service	480 V, 3 phase
Emergency power	normal and emergency disconnect switches with single common key; no MTS
Security Protection	Intrusion alarm
Mechanical	
Ventilation	Ventilation exhaust fan
Heating	Dayton propane heater
Plumbing	
Operational Notes	
	Cleaned 12/17/1996, video'd

ASSET INVENTORY	
MERRIMACK VILLAGE DISTRICT TOWN OF MERRIMACK, NH	
Name: Well #3	
Updated: February 2014	
Improvements Needed	
	New VFD, to allow soft start and turndown
	New chlorinator eventually
	New lime station, additional lime storage
	Well level monitoring, SCADA RTU upgrade
	Fe/Mn treatment

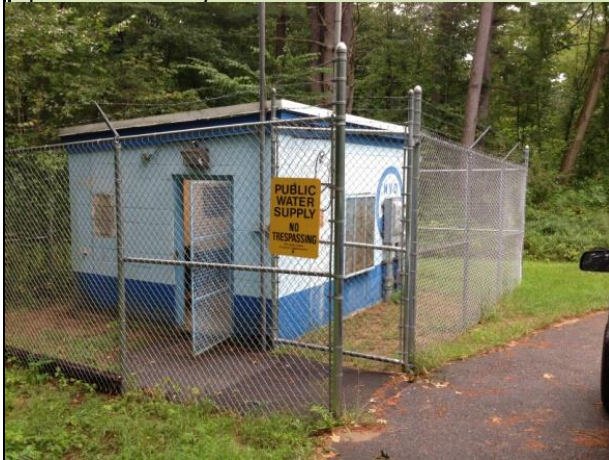
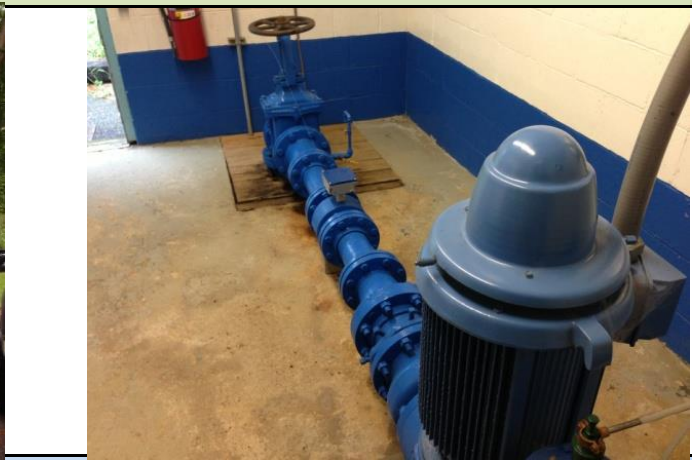
ASSET INVENTORY	
MERRIMACK VILLAGE DISTRICT TOWN OF MERRIMACK, NH	
Name: Well #4	
Updated: February 2014	
Well Information	
Well type	gravel pack
Casing size, in	12 inch
Grade elevation, ft MSL	124 per water model
Suction depth, ft	42
Well depth, ft	55
Approved yield, gpm	about 200 gpm; see Well #5 for aquifer limits
Last cleaning date	2009
Water quality	good
Notes	not sure if rescreened
Instrumentation	
Flowmeter	4" magmeter
Level monitoring	none
Chorine monitor	n/a (at well 5)
pH monitor	n/a (at well 5)
Pressure sensor	none
Telemetry	SCADA RTU/Radio telemetry
Structural/Architectural	
Size	183 SF
Building walls	CMU block
Roof	Flat
Doors	Single Steel
Electrical	
Primary Service	480 V, 3 phase
Emergency power	none
Security Protection	Intrusion
Mechanical	
Ventilation	
Heating	
Plumbing	
Operational Notes	
	4/16/2007 electrical upgrade
	Affected by operations at Well 5
	2009 Emergency repairs - pump, motor, shaft
	2009 clean and surge

ASSET INVENTORY	
MERRIMACK VILLAGE DISTRICT TOWN OF MERRIMACK, NH	
Name: Well #4	
Updated: February 2014	
Improvements Needed	
	spare board for soft start
	Consider decommissioning and just using Well 5

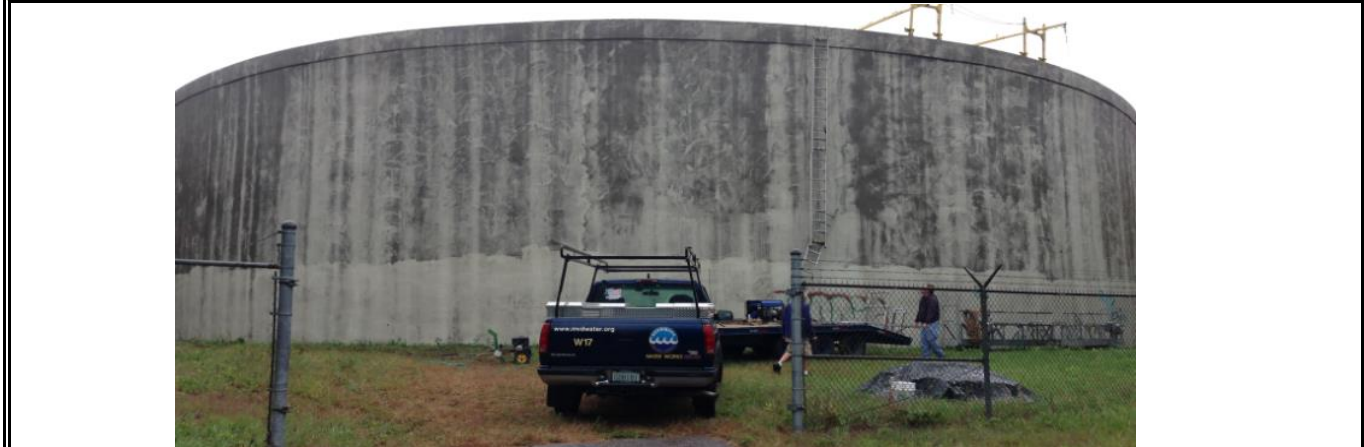
ASSET INVENTORY	
MERRIMACK VILLAGE DISTRICT TOWN OF MERRIMACK, NH	
Name: Turkey Hill Tank	
Updated: February 2014	
Structural	
Material	Prestressed Concrete
Shape	Circular
Roof Hatch	30" x 30" square hatch
Shell Hatch	N/A
Piping	Common Inlet/Outlet Pipe
Pipe Diameter	12"
Material	
Penetration	
Silt Stop	Yes
Drain Pipe	
Roof Cover	Fixed Roof
Instrumentation	
Telemetry	SCADA - RTV/ radio telemetry
Level	pressure transducer
Hydraulic Data	
Nominal Volume, gallons	4,000,000
Volume, gallons	4,230,100
Useable Volume	4,230,100
Tank diameter	150'
Max Height	32'
Base Elevation ft, MSL	359
Maximum Fill Rate, gpm	
Maximum Draw Rate, gpm	
Electrical	
Primary Service	
Emergency power	
Security Protection	
Operational Notes	
	Possible issues with Poor Turnover
	2010, Underwater Solutions cleaned and inspected w/ diver, removed 10" of sediment.
	Sept 11 and 12, 2014, Underwater Solutions cleaned, reportedly > 8" of sediment.
Improvements Needed

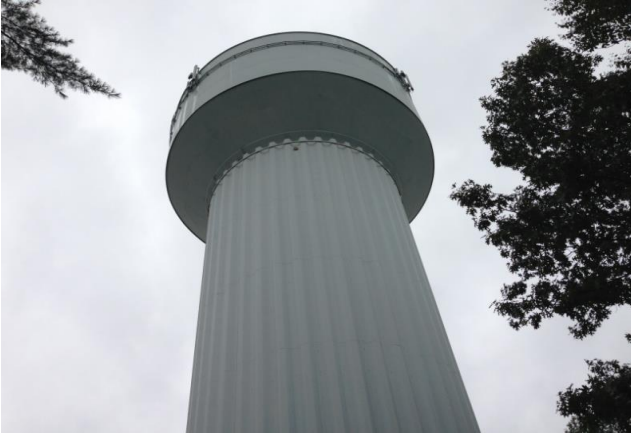
ASSET INVENTORY	
MERRIMACK VILLAGE DISTRICT TOWN OF MERRIMACK, NH	
Name: Lake Road Tank	
Updated: February 2014	
Structural	
Material	
Shape	
Roof Hatch	
Shell Hatch	
Piping	
Pipe Diameter	
Material	
Penetration	
Silt Stop	
Drain Pipe	
Roof Cover	
Instrumentation	
Telemetry	
Level	
Hydraulic Data	
Nominal Volume, gallons	750,000
Volume, gallons	
Useable Volume	
Tank diameter	64
Max Height, ft	156
Base Elevation ft, MSL	498
Maximum Fill Rate, gpm	
Maximum Draw Rate, gpm	
Electrical	
Primary Service	
Emergency power	
Security Protection	
Operational Notes	
	Out of service since 2001.
	Tank does not turnover, resulting in low residual.
Improvements Needed
